HYDROGRAPHIC SURVEY FOR SEARCH AND RESQUE IN SHALLOW WATER AND DEEP WATER

CASE STUDY : AIR ASIA AND ADAM AIR CHRASES

By :
PUSHIDROSAL
(INDONESIAN HYDROGRAPHIC AND OCEANOGRAPHIC CENTRE)

EAHC 5TH CARTOGRAPHIC AND HYDROGRAPHIC COMMITTEE
SINGAPORE , 18-21 OCTOBER 2016

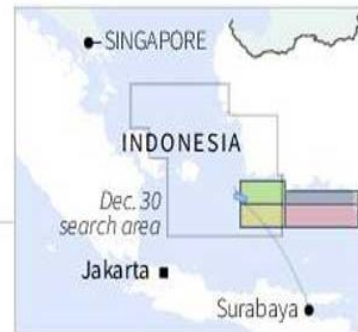
Search area and assets deployed on Jan. 9.

Search aircraft deployed:

Area:	I	II	III	IV	"Most probable area"
Aircraft:	AS-332	Unspecified	BE-200	P3	P3
Altitude:	2,000 ft	1,500 ft	1,000 ft	500 ft	1,500 ft
Operator:	Singapore	—	Russia	Korea	Korea

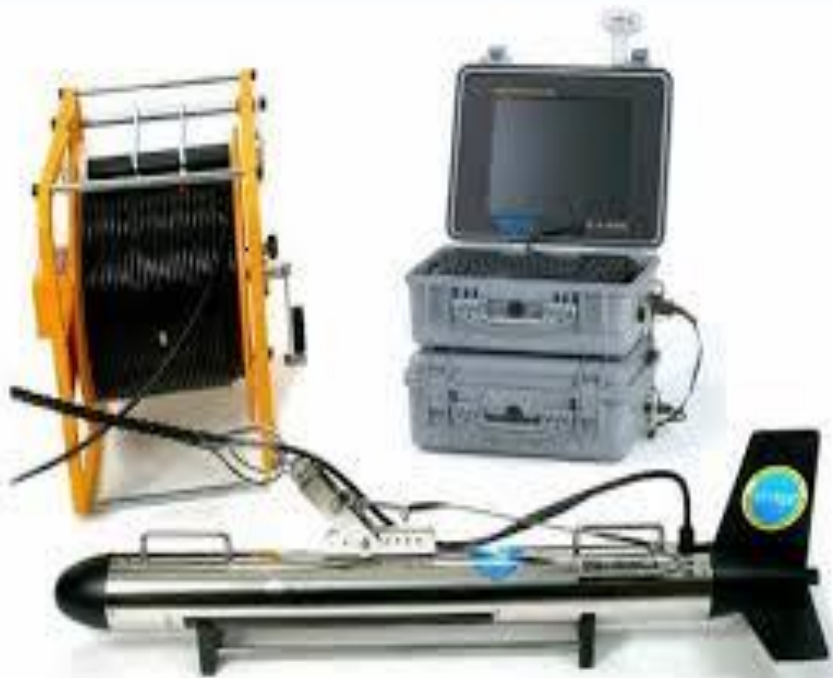
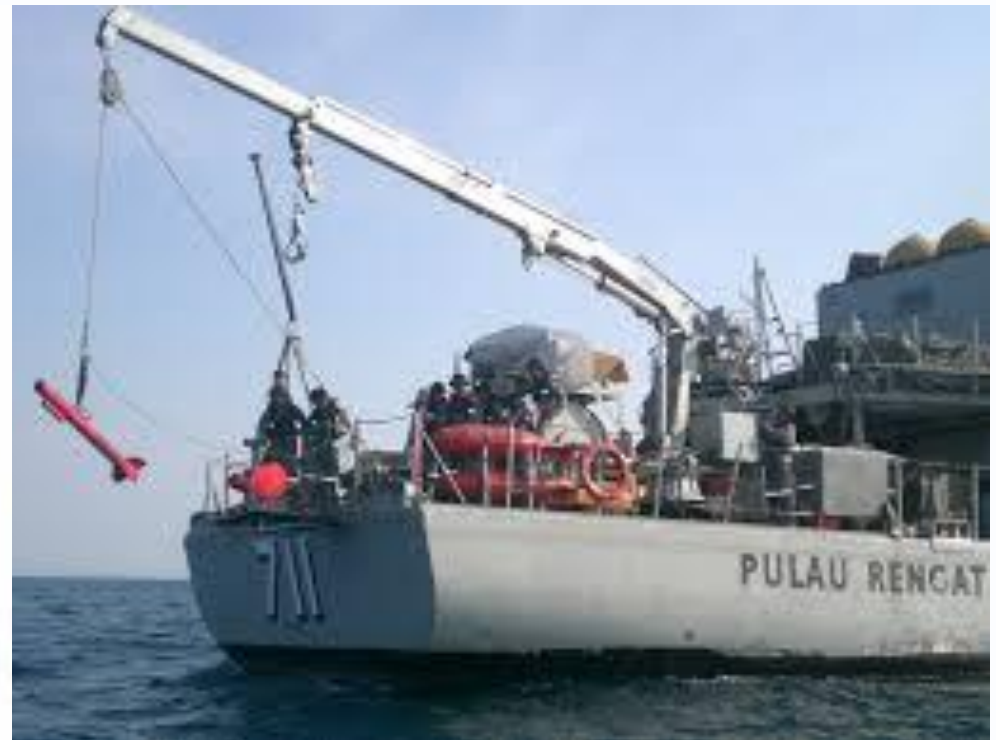
SIDE SCAN SONAR

DEPICTING OBJECTS/DEBRIS ON THE SEAFLOOR

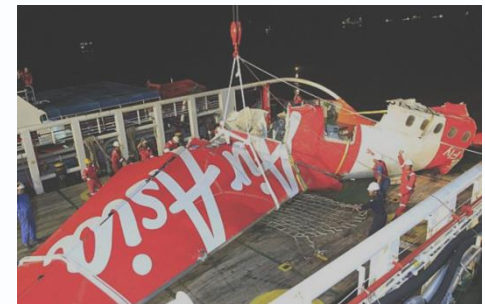
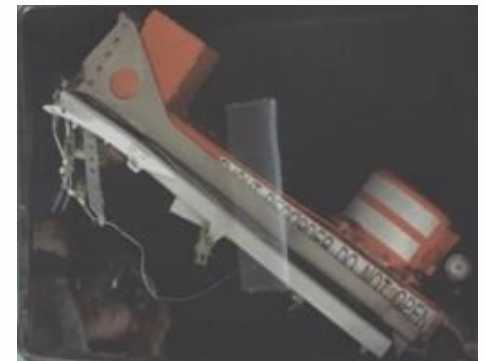
Simrad: WinHPR1 - WinHPR1

Filtered Position data:

Item	Position	Depth
EMA	S 06 06.1360 E106 53.2145	0.00
EMB	S 06 06.1359 E106 53.2144	0.00
Kri S	S 06 06.1359 E106 53.2144	21.39

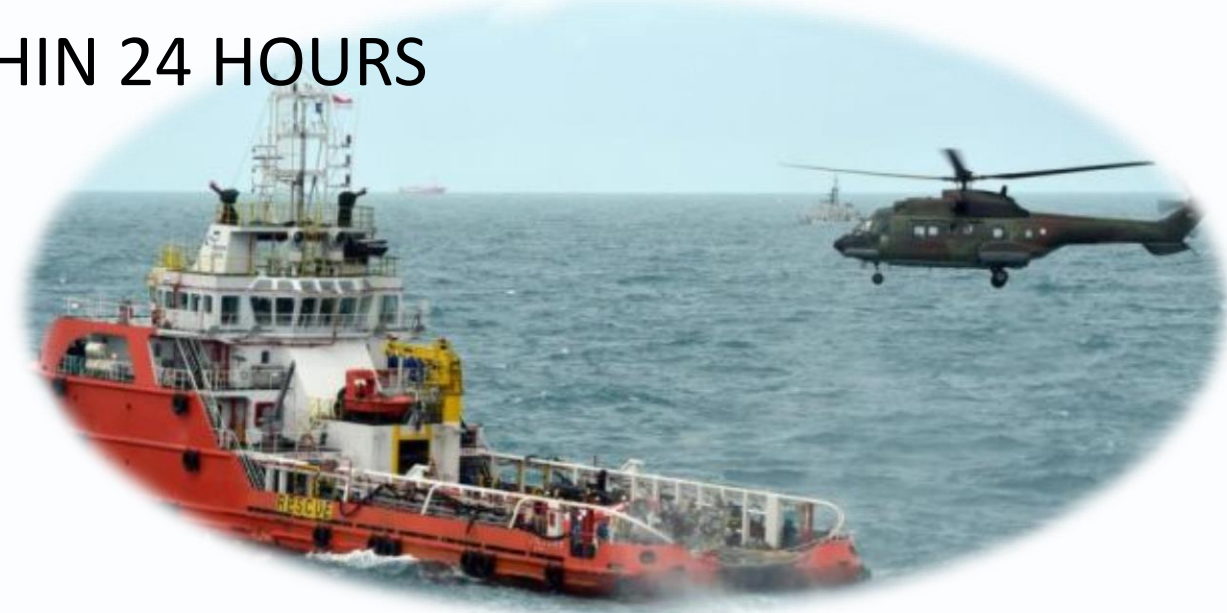
AIR ASIA QZ8501

· WATER DEPTHS RANGED BETWEEN ONLY 25M AND 38M

THE MISSION WAS ABLE TO DETECT EIGHT SUSPECTED OBJECTS IN ROUGHLY 12KM BY 15KM SURVEY AREA WITHIN 24 HOURS

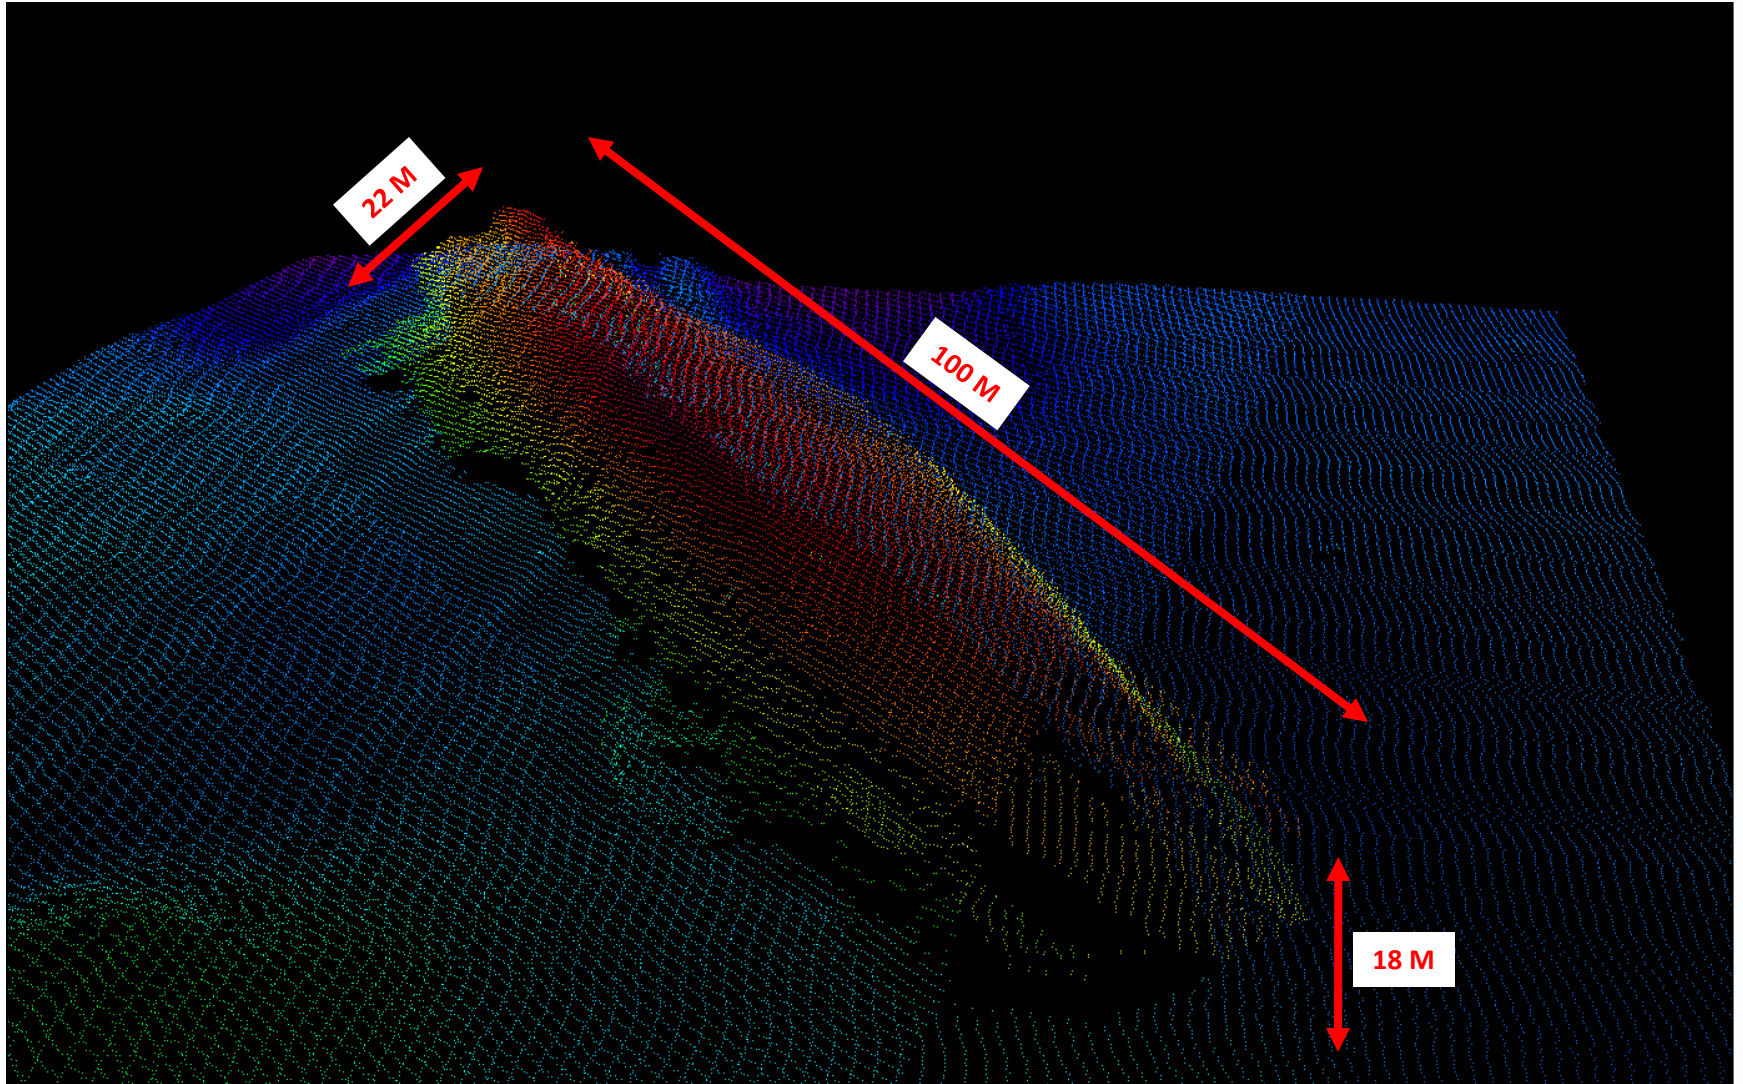
DIMENSI WRECK BAHUGA JAYA

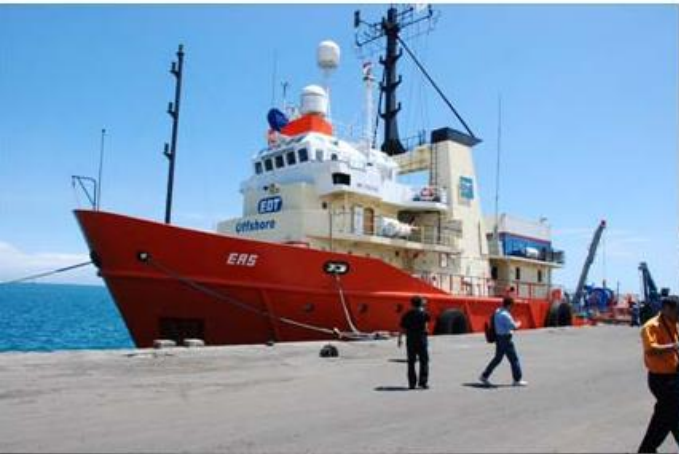
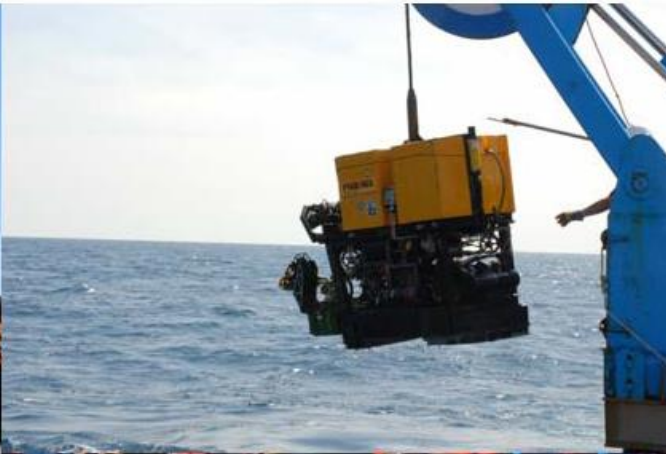
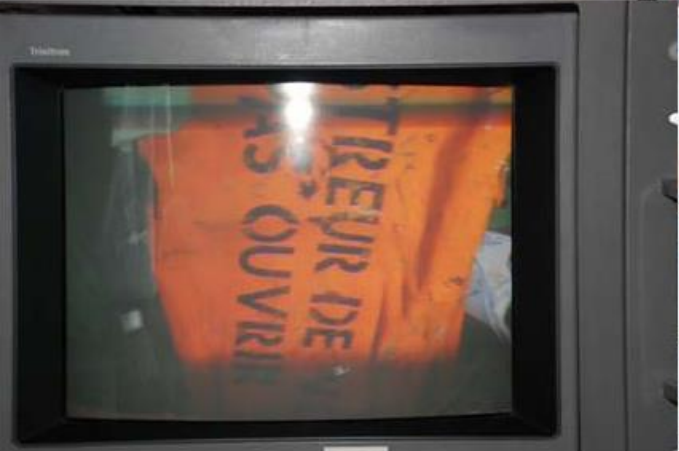
DEEP SEA OPERATION TO SEARCH ADAM AIR

ROV, *Remora 6000*, which was capable of descending to a water depth of 3000 meters

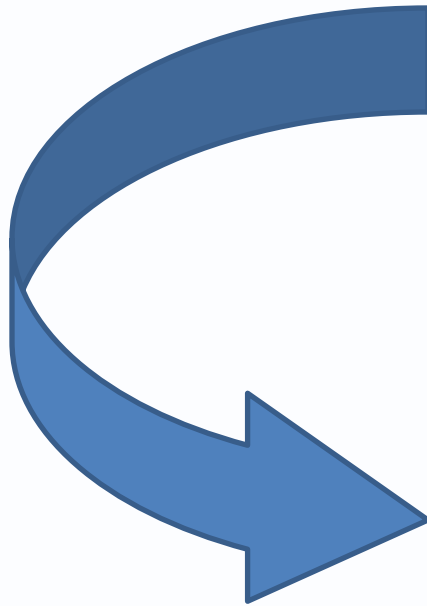
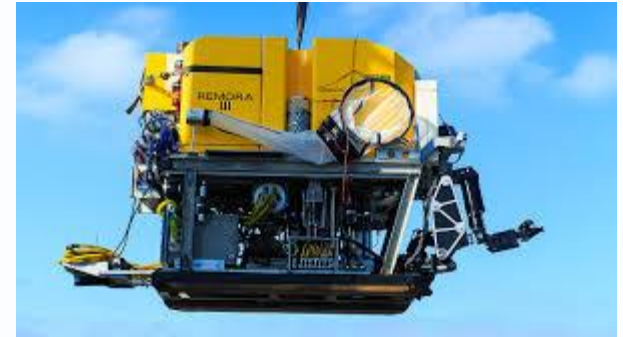
ROV REMORA 6000 USED FOR ADAM AIR SEARCH

The underwater survey and recovery used a small ROV, *Remora 6000*, which was capable of descending to a water depth of 3000 meters. The ROV had three visual cameras and two fixed lights fitted on the front of the vehicle, which were used for visual scanning. The visual range of the camera was about 10 meters. The ROV was also equipped with underwater sonar with good resolution horizontally up to 100 meters. computer

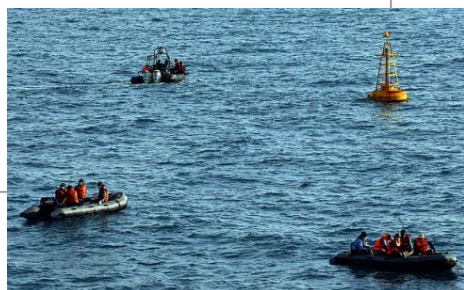
Fuselage

CVR

Cockpit

FDR

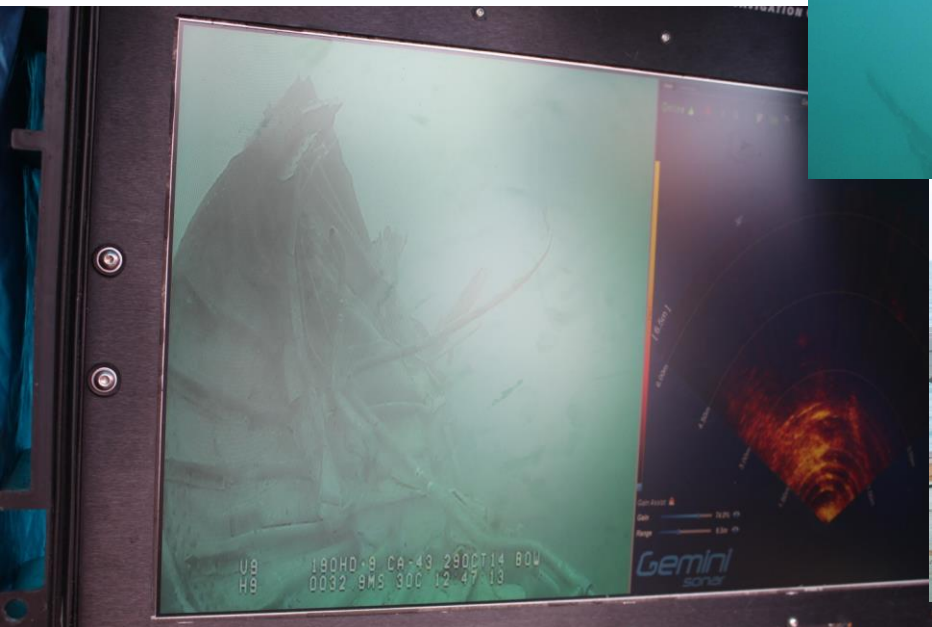
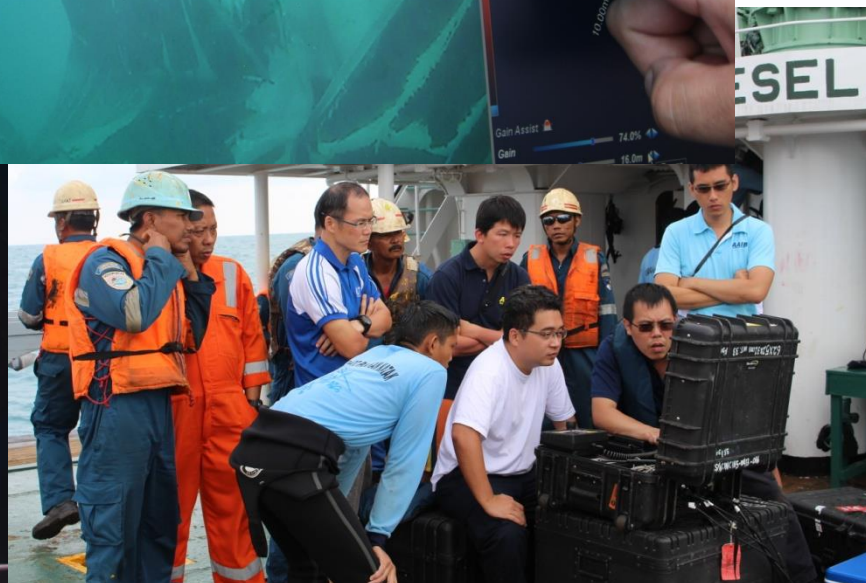
Side Scan Contacts confirmed by ROV and Divers
