The Search for AirAsia QZ8501

Edwyn Ang / Technical Officer
Hydrographic Department / Port Services
18 October 2016

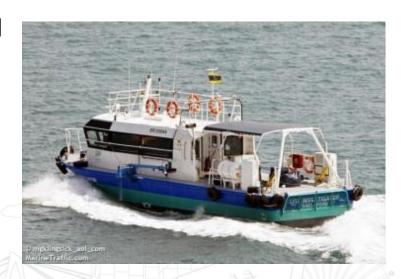
- 2 Surveyors on 24 hrs standby rotation with
 - Survey launch with multibeam and sidescan survey systems
 - Response time
 - 2 hours within office hours
 - 4 hours outside office hours
 - ROV can be deployed if necessary
 - Bouy Tender on standby
 - Isolated danger buoy ready to be deployed at all times

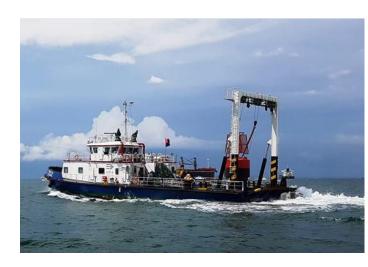
- Lita Discovery and Lita Investigator
 - Survey launches with multibeam survey systems
- Panduan
 - Buoy Tender
- Mata Ikan
 - Hydrographic Vessel with multibeam survey system
 - Also ready for sidescan survey and remote operated vehicle (ROV)

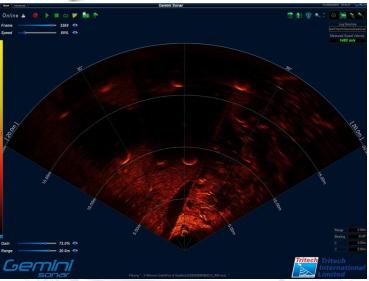
Remote Operated Vechicle

- Identification & verification of underwater contacts detected by MBSS and SSS
- Video camera capabilities
- Underwater inspection of beacon structures
- Commissioned in 2010

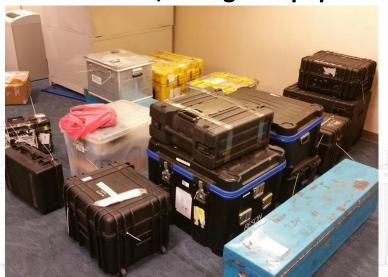
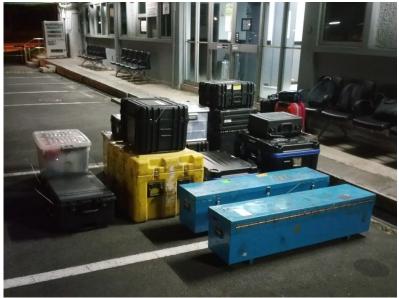
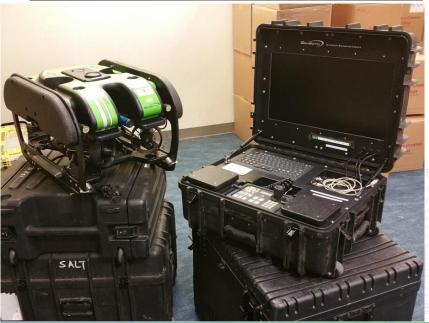
Survey Equipment

- 2 x Side Scan Sonar Systems
- 3 x Armoured Cables
- 1 x Remote Operated Vehicle System
- 3 x Omnistar DGPS System
- 7 x Laptops with Survey Acquisition and Processing Software
- 2 x Display Monitors
- 1 x Power Regulator

In Total 16 Boxes, 350kg of Equipment

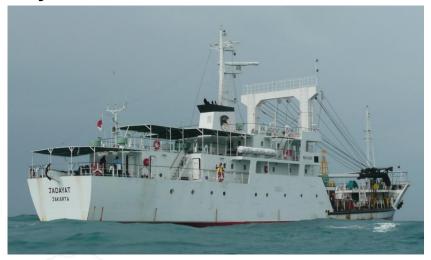
Survey Platform

- Vessel provided by Directorate General Sea Transportation of Indonesia
- Buoy Tender Jadayat & Andromeda

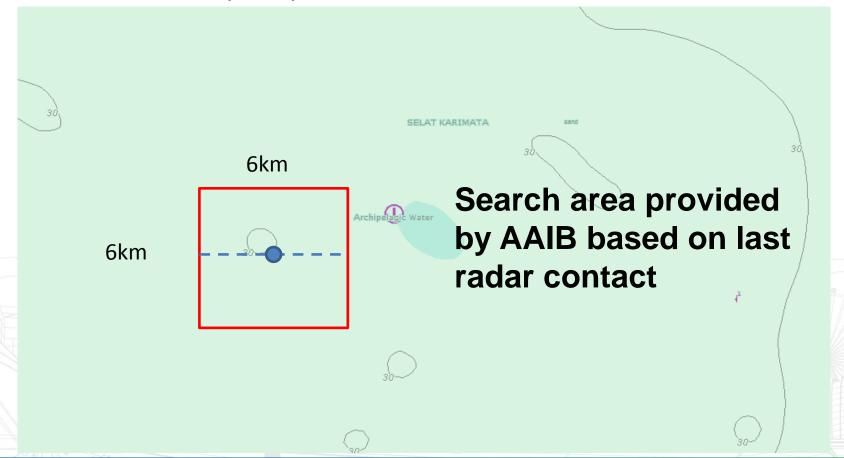
The Search Area

6km x 6km

- Jadayat (North) 3 x 6km
- Andromeda (South) 3 x 6km

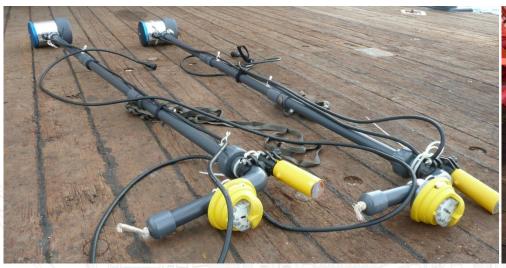
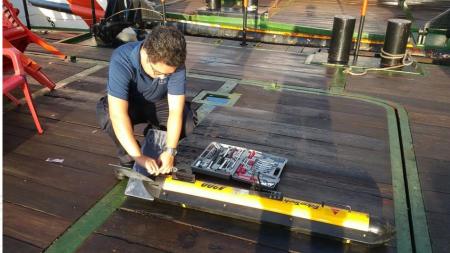
Search Method

Hydrophones combined with side scan survey

- Hydrophones were used to triangulate the position of the crash site
- Once a possible site is identified, side scan sonars were deployed to conduct a survey of the area

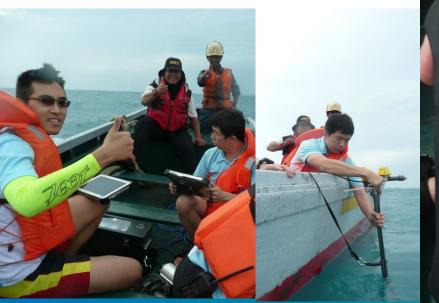
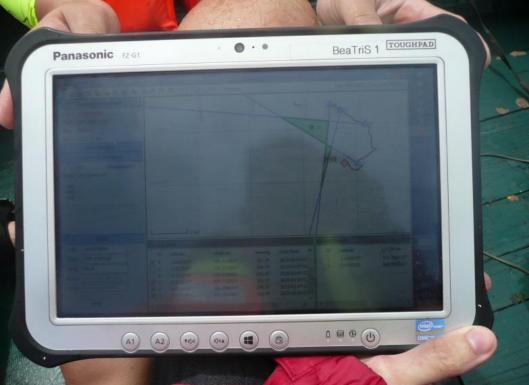
Hydrophones were used to detect the acoustic ping transmitted from the black boxes underwater locator beacon

Triangulation of this acoustic ping allowed us to narrow down search area

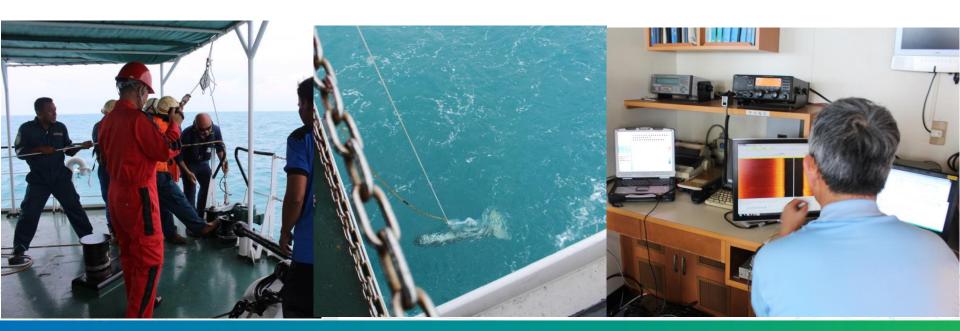
Sidescan Sonar

- Easy to setup for deployment
- Deployed when survey area was established
- Provides a visual image of the seabed
- Provides a wide search area

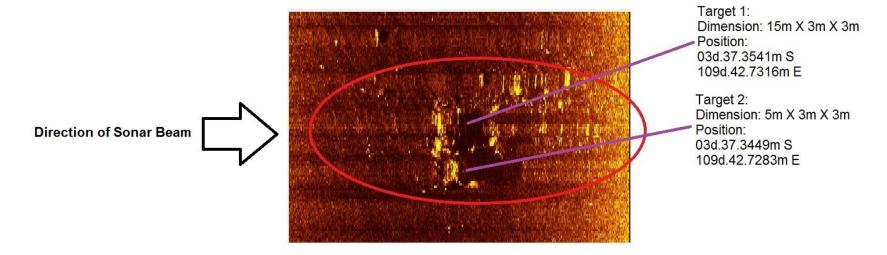
SIDE SCAN SONAR IMAGE of DEBRIS FIELD

- 1) Model of Side Scan Sonar: Edgetech 4200 @ 100kHz and/or 400kHz.
- 2) Positioning: SeaSTAR-HP 8200 HP DGPS
- 3) Size of Debris Field at 100m X 40m.

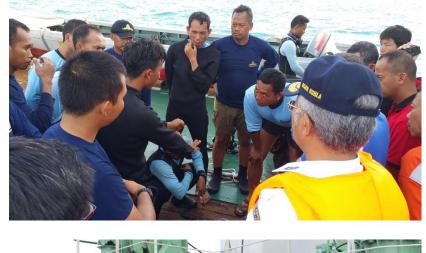
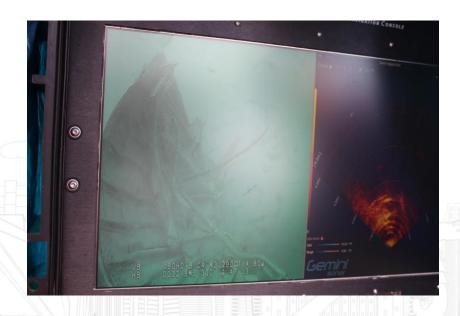
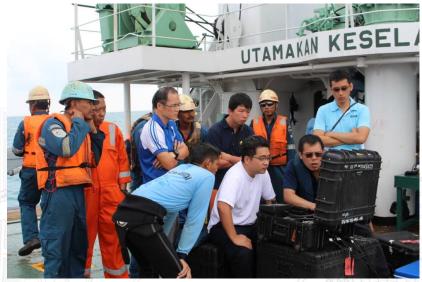
Search Verification

Verify Suspicious Contact

- Remote Operated Vehicle (ROV)
- Indonesia Naval Divers

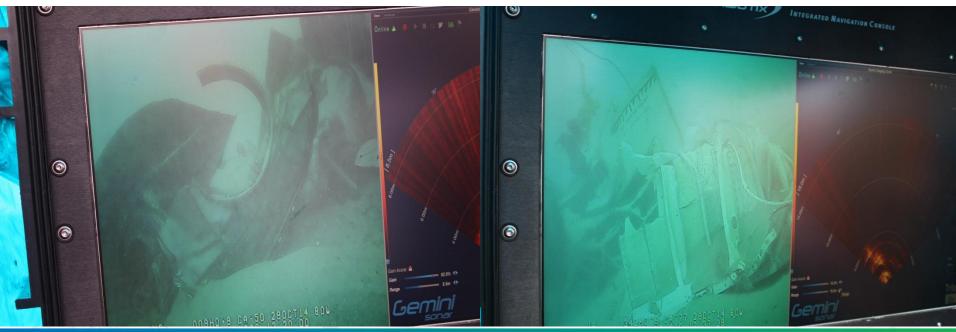
ROV

- Provides video image of the object on the seabed
- Maximizes dive time of divers which is limited
- Provides images for divers warning them of any danger before diving

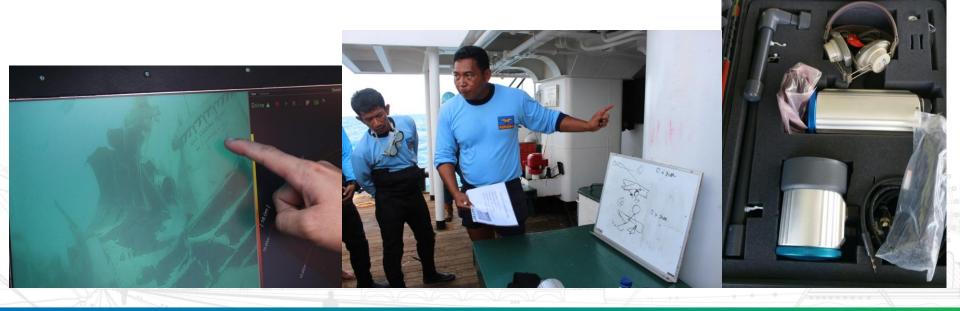
Search for the Black Boxes

Flight Data Recorder (FDR) and Cockpit Voice Recorder (CVR)

- Divers with handheld hydrophones to pinpoint the location within the debris field
- Experienced AAIB officials confirms visual images from ROV is the part of the tail of the wreckage containing the blackboxes

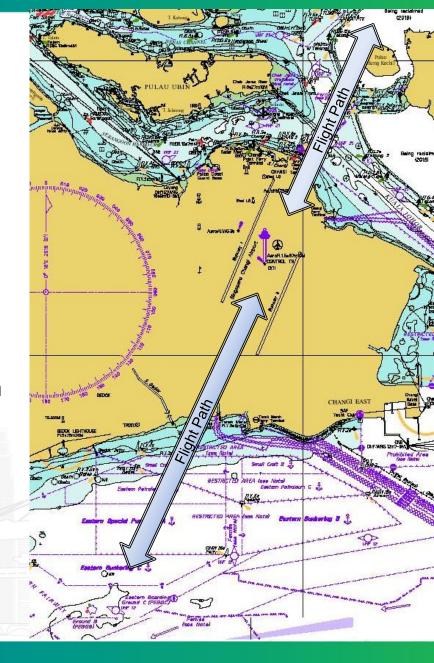
Mapping of Seabed Below the Flight Path

Establishment of seabed classification and backscatter

- The database of the sea area around the flight paths are constantly updated with survey data containing backscatter and seabed classification information
- AirAsia experience reaffirms usefulness of seabed classification information
- Allows surveyor to identify new objects easily
